Manhole Inspection Summary

Manhole # S43UU_015MH

Insp Date: **2/9/07 1:40 PM**

Location Address: **2804 KENNEDY AVE**

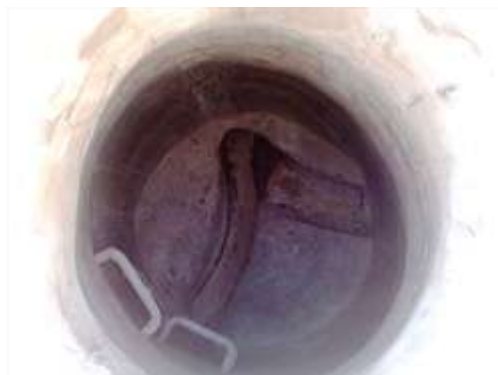
Top View

Bench debris.

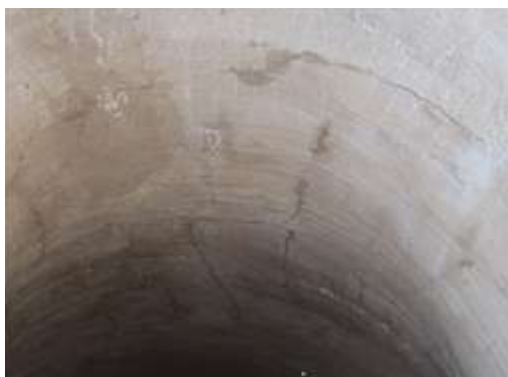
Defect

Infiltration: ☐ None ☒ **Joint** ☐ Cracks ☐ Mortar ☐ Roots ☒ **Wall**

Infiltration: ☐ None ☐ Joint ☐ Cracks ☐ Mortar ☐ Roots ☒ **Wall**

Corbel and Barrel infiltration.

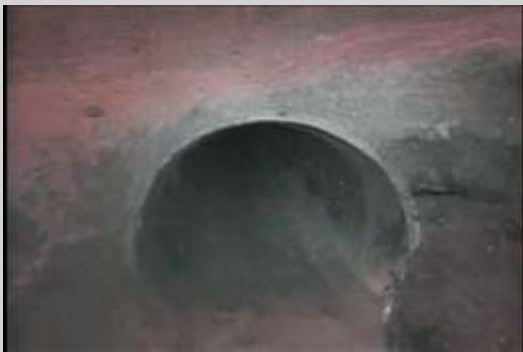
8 in. Circular Gravity Sewer Pipe Out @ 12 O'Clock

Pipe Material: **Unknown** ☒ Pipe Lined

Invert Depth: **9.05** (ft.) Flow Characteristics: **Slow**

Infiltration: **None** Pipe Seal Cond: **Sound**

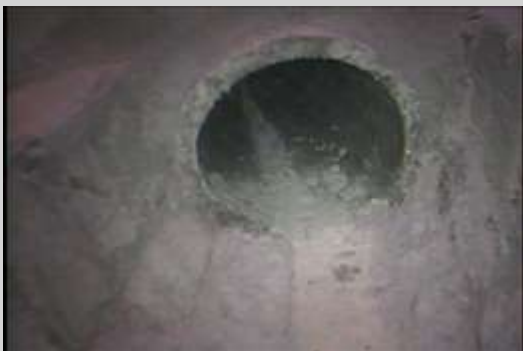
6 in. Circular Gravity Sewer Pipe In @ 4 O'Clock

Deposits: ☐ None ☐ Mud ☐ Sludge ☐ Debris ☒ Grease

Silt Depth: **0** (in.) Deposits Extent: **Light**

Infiltration: **None** Pipe Seal Cond: **Unknown**

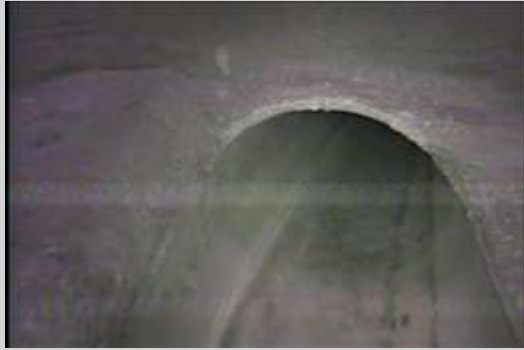
8 in. Circular Gravity Sewer

☒ Pipe Lined

Invert Depth: **8.78** (ft.) Flow Characteristics: **Slow**

Pipe Seal Cond: **Unknown**
